Using Craftsmanship to Detect Defects and Improve Reliability

By Glen Bertini, Novinium

The P1816 guide, which will be available this year, begins where component installation instructions end. The P1816 guide, also known by its long title, "Guide for Preparation Techniques of Extruded Dielectric, Shielded Cable Rated 2.5 kV through 46 kV and the Installation of Mating Accessories," provides the consensus best practices required to provide decades of reliable service.

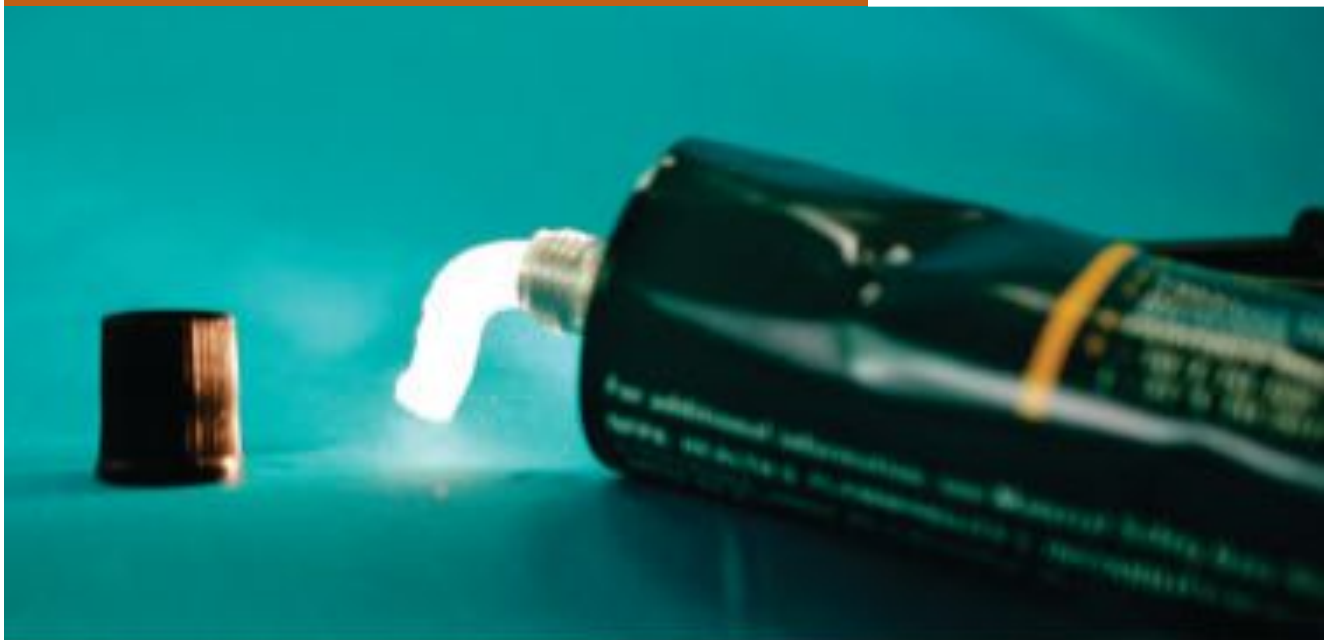
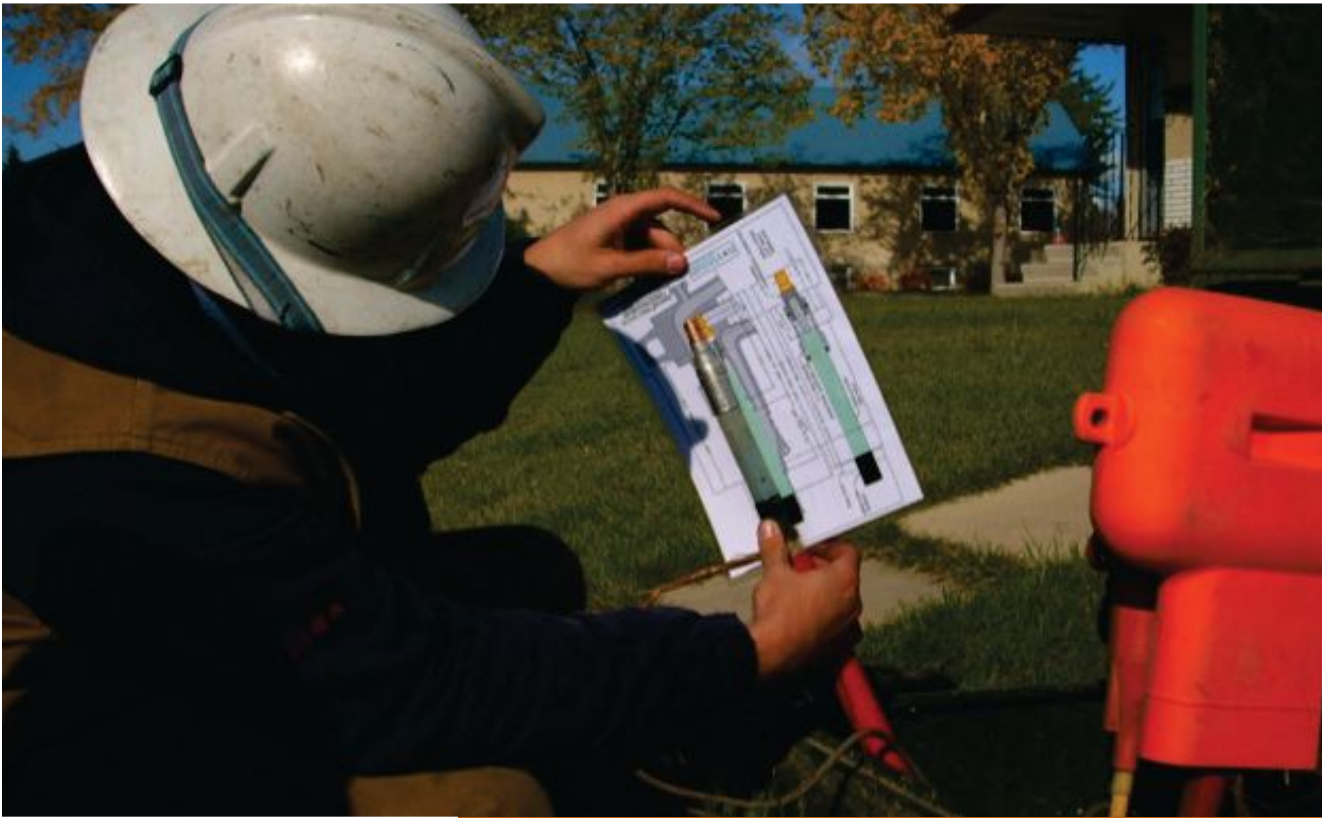
Figure 3. A craftsman in Alberta uses a template to make sure all of the cutbacks line up within appropriate tolerances. The component is shown in cut-away, so that the craftsman can visualize how his work fits within the internal mechanisms of the component.

At Novinium, we have virtually eliminated cutback errors by replacing the ruler with a life-size, “anatomically correct” template. Figure 3 illustrates such a template in use. The template shows the conductive insert length, which otherwise would be invisible. Another template feature is a pre-crimped view of the assembly (to the right in the illustration) and a post-crimped view. Since the process of crimping or swaging lengthens the assembly, having both views allows the craftsman to confirm all of the dimensions before committing to an irreversible crimp.

We create and use templates on all dead-front components at Novinium. To create our templates, we slice an actual component along its axis and make careful measurements of the internal and external dimensions. We then make an engineering drawing at a one-to-one scale with all of the

subcomponents accurately depicted. Important dimensions are added and the template is laminated, so that it may be used many times – even in foul weather. Unfortunately, component suppliers do not supply these today because end users do not require them. The cost of a disposable paper template is pennies and a more durable plastic template is just a few dollars. A single reliability problem with URD cable results in a cost of about \$5,000, so the cost of purchasing a template can pay for itself quickly.
